**No. IACS Model Report for IMO Resolution  
102 MSC.215(82) Annex 1 “Test Procedures for  
(June Coating Qualification”, Section 1.7 - Crossover  
2008) Test**

# EXAMPLE COATING PRODUCER

BALLAST TANK COATING TEST OF 2 \* 160  $\mu$ M  
EXAMPLE EPOXY PAINT ON EXAMPLE SHOP  
PRIMER

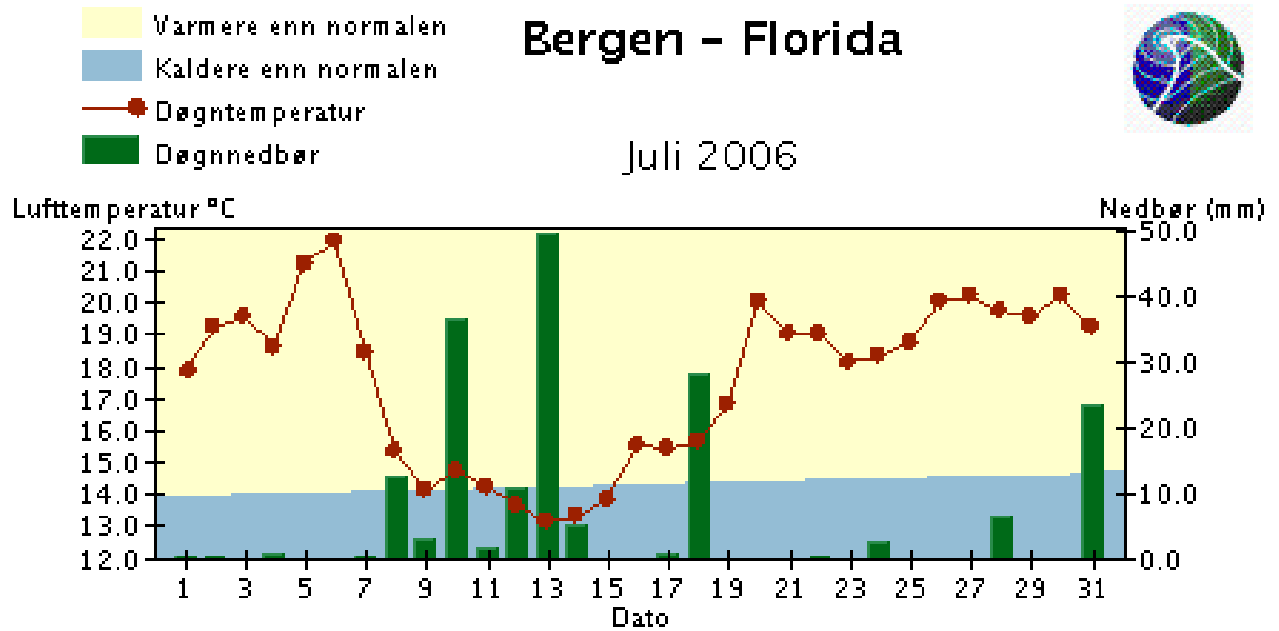
## 9 APPENDIX A - ENVIRONMENTAL DATA - WEATHERING OF SHOP PRIMED PANELS

Example zinc silicate shop primer was applied to the blast cleaned panels according to the data given in Table 2. The shop primed panel were then exposed out-door for 2 months. The environmental data for the exposure period is given in Appendix A.

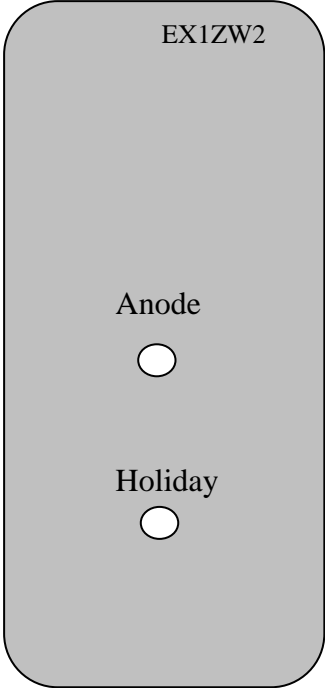
Figure B-1 Coding.

The panel were coded as shown in Figure B-1 in Appendix B.

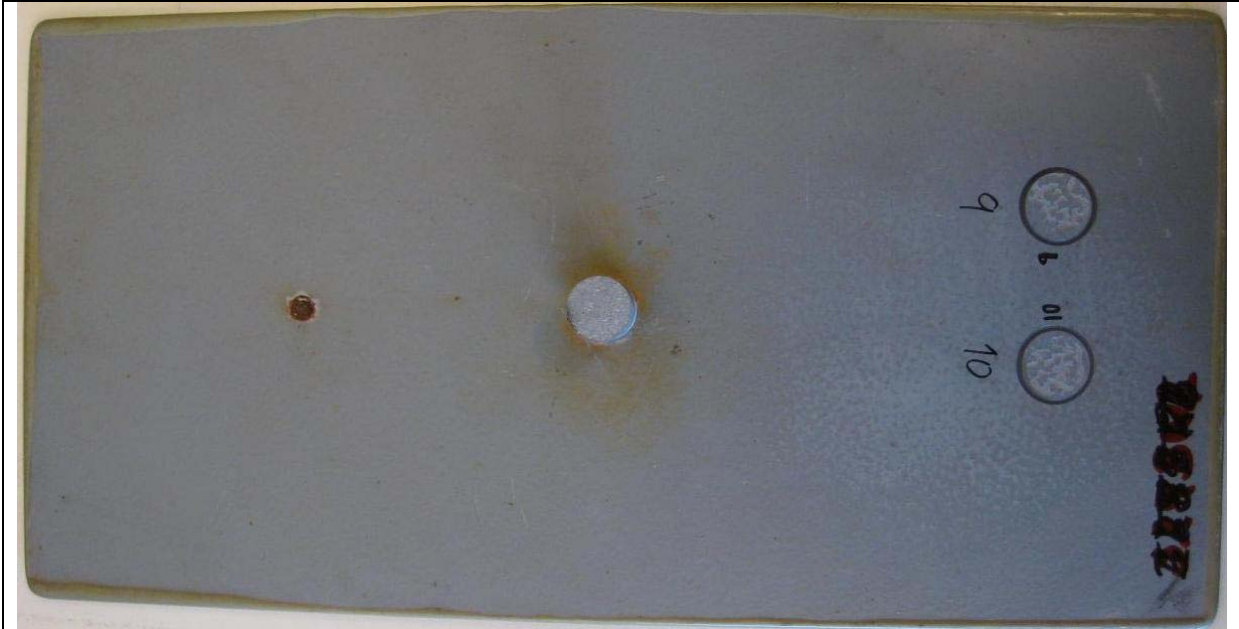
Panel	Cathodic disbondment (mm)	Blisters / rust	Zinc anode weight loss (g)	Current demand (mA/ m <sup>2</sup> )
EX1ZW2	7.2	0	1.2345	3.32

Additionally IACS interpretation of IMO PSPC: Repeat the cutting and lifting all around the artificial holiday to find the maximum loss of adhesion. Disbonding from artificial holiday can be either loss of adhesion to the steel substrate or between the shop primer and the epoxy coating and shall be less than 8 mm for epoxy based systems to be acceptable (compatibility test). Cohesive adhesion failure in the shop primer is not to be included as part of the loss of adhesion.

Figure C-1 Disbonding from artificial holiday, bottom wave tank panel (example picture not connected to example results in this model report).

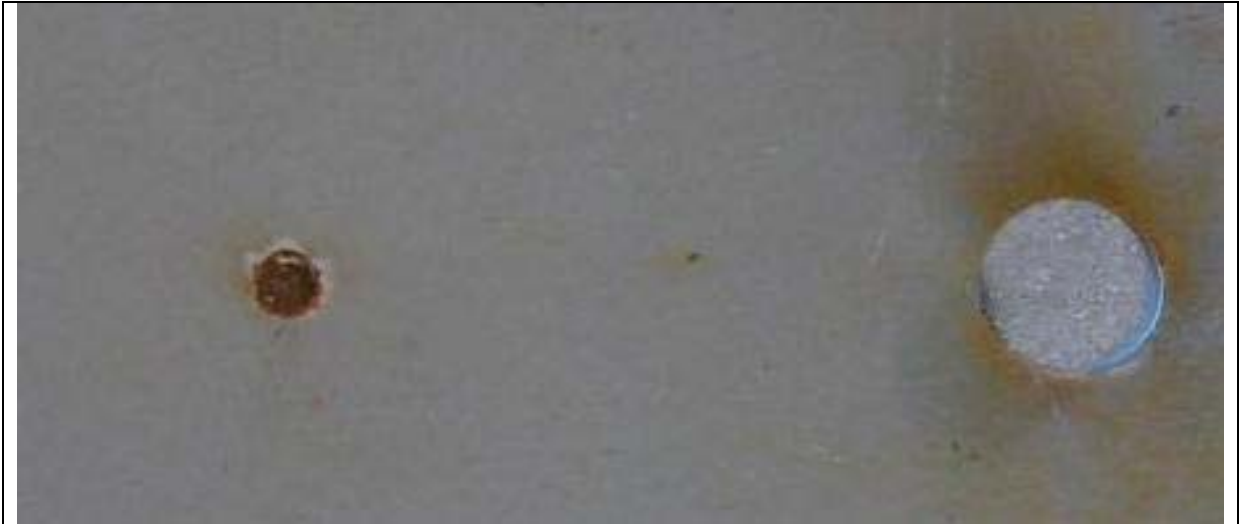
Figure C-2 Disbonding from artificial holiday, bottom wave tank panel (example picture not connected to example results in this model report).
