LL63

Treatment of steps and recesses in transverse subdivision bulkheads: IMO Res. A.320 (IX), paragraphs 12(d) and 12(e), and Regulation 27(12)(d) and (e), Revised 1988 ICLL (MSC.143(77))

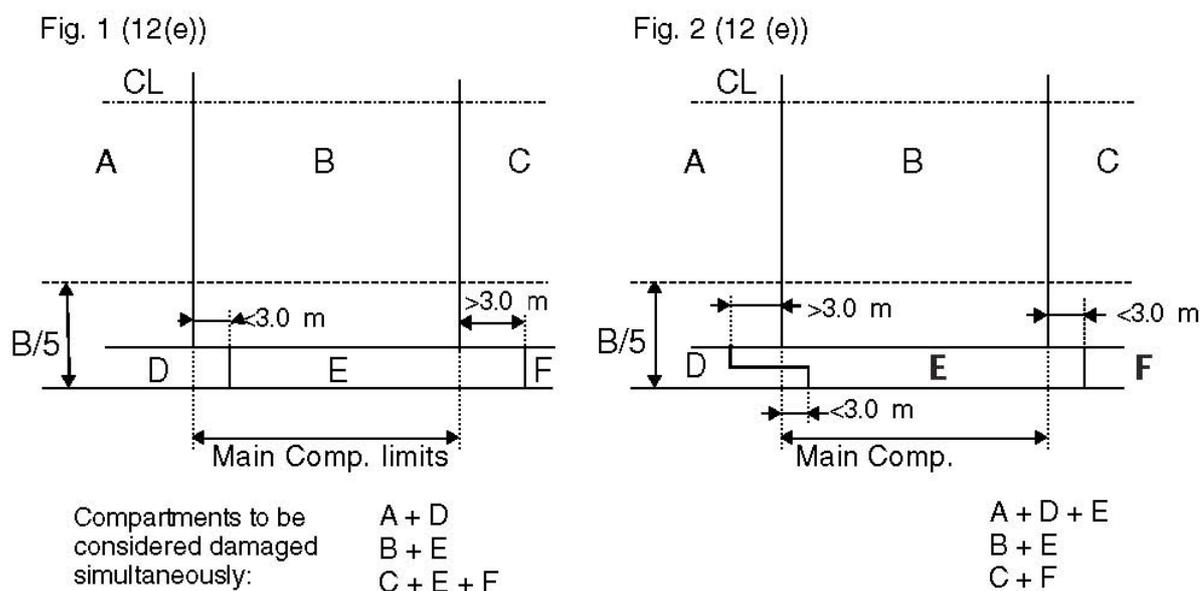
Representative examples to clarify treatment of steps within the transverse extent of damage

Such a step or recess should be assumed not to be damaged provided that, either:

- the longitudinal extent of the step or recess, measured from the plane of the main transverse bulkhead, is not more than 3.0 metres, or:
- any longitudinal surface forming the step or recess is located inboard of the assumed damage.

Where, otherwise, the transverse and longitudinal bulkheads bounding a main inboard compartment are entirely in board of the assumed damage position, damage is assumed to occur between the transverse bulkheads of the adjacent wing compartment. Any step or recess in such wing tank shall be treated as indicated above.
